HOMETECH HOME INSPECTIONS

# INSPECTION REPORT SUMMARY

10358 Misty River Drive, Houston, TX, 77086

Sep 11th, 2026

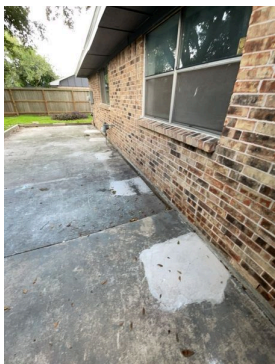
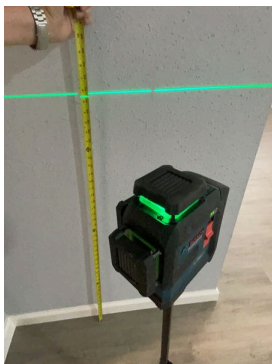
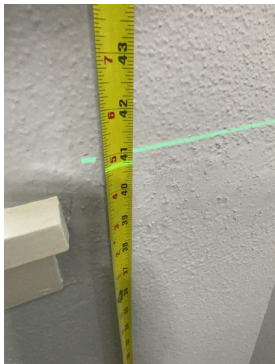
There is evidence of previous foundation repairs. The repair seems to have stabilized the foundation, and no additional indication of movement is seen at time of inspection. Recommend a qualified foundation expert evaluate further.

Foundation was measures in multiple locations using a laser level and all test point were withing specifications of less than 1" movement within 20'.

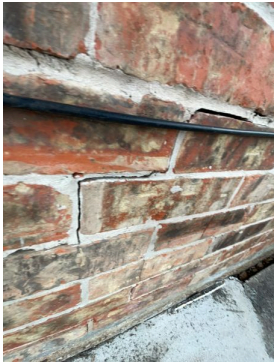
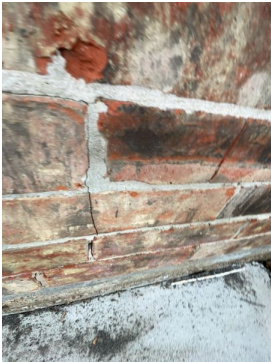
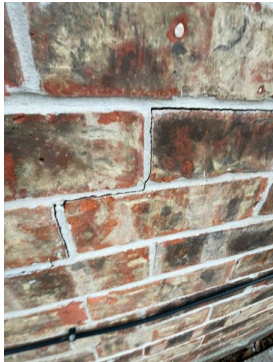
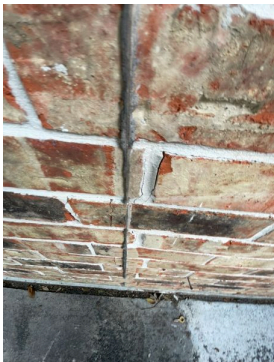
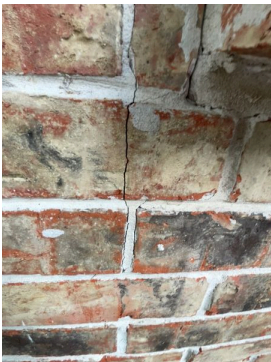
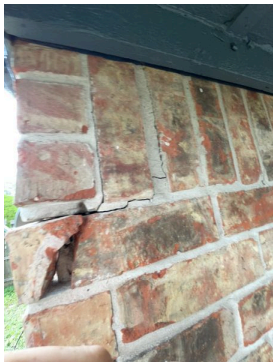
There was potential structural cracking noted in the brick veneer at the foundation. This is most likely cracking before previous foundation repair. At this point there is no evidence of further movement. Recommend a structural engineer evaluate and get warranty documentation from foundation company the did leveling.

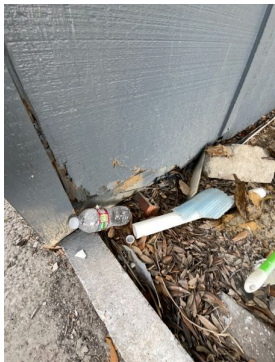
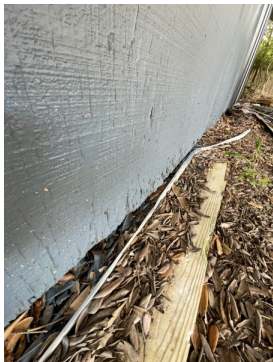
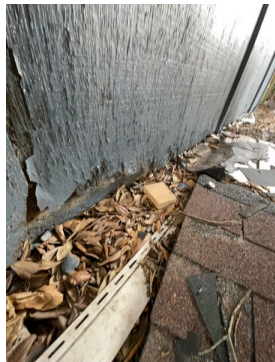
There was wood rot observed around the garage base walls. Recommend repair and observation for the source of the moisture to reduce the risk of re-occurrence.

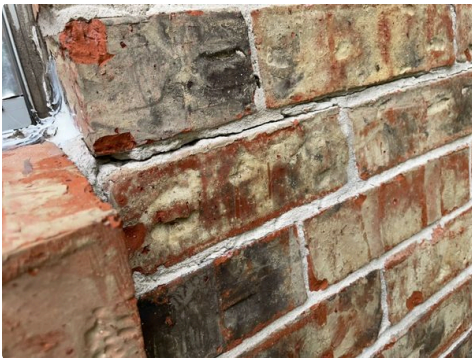
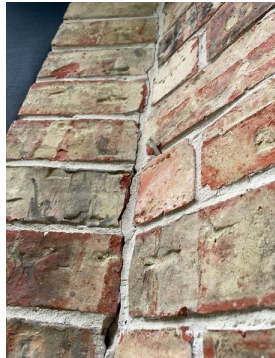
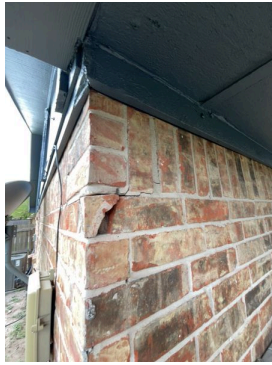
There are cracks in one or more areas of the brick/stone veneer mortar joints. Client may wish to seal the cracks in the brick veneer to reduce the risk of pest and water intrusion. This is most likely cracking before previous foundation repair. At this point there is no evidence of further movement. Recommend a structural engineer evaluate and get warranty documentation from foundation company that did leveling.

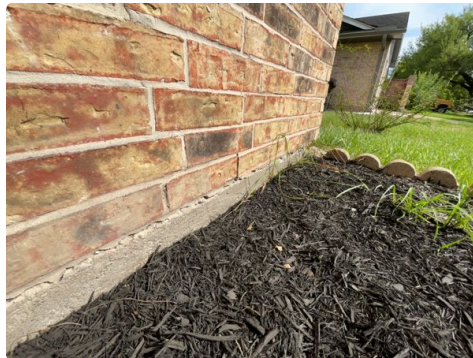
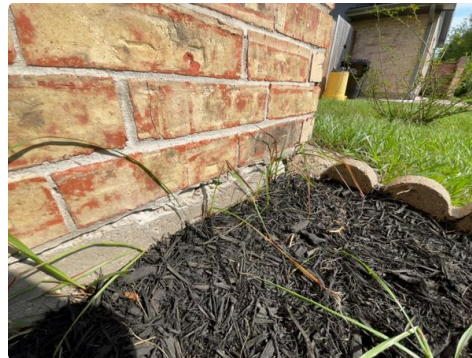
There are cracks in one or more areas of the brick veneer mortar joints. These are not structural in nature. Client may wish to seal cracks to reduce the risk of pest and water intrusion.

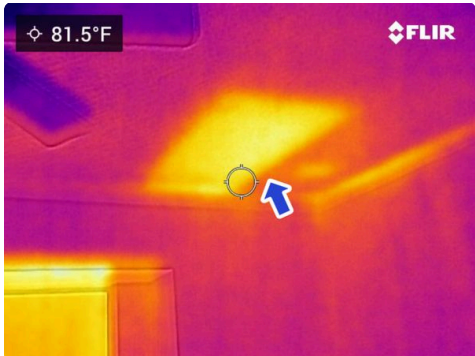
Missing insulation was observed in ceiling bedroom #2, possibly due to a prior repair. This can reduce thermal performance and increase energy costs. Recommend repair or replacement by a qualified insulation contractor.

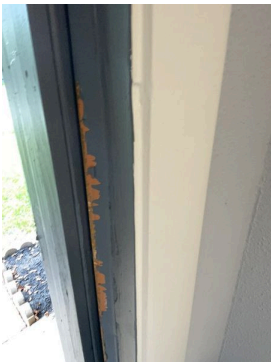
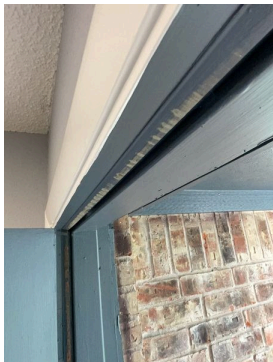
The front door is jamming in the door jamb when opening or closing, indicating misalignment or binding within the frame and appears to be caused by the weather stripping. This was observed during door operation testing. Jamming doors can cause difficulty with daily use and may lead to damage to the door or frame if forced. A carpenter should inspect the door alignment, frame condition, weather stripping, and hinges to determine the cause and make necessary adjustments or repairs.

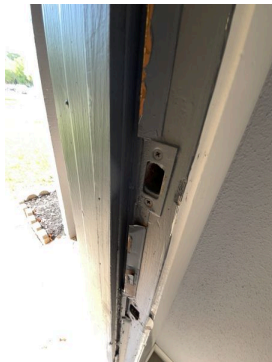
There was a front door deadbolt that would not engage when the door was closed. This did not appear to be caused by structural movement. Recommend repair of the latch and/or strike plate.

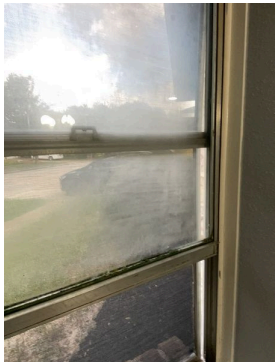
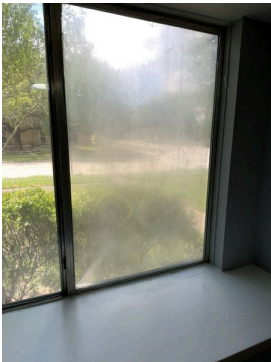
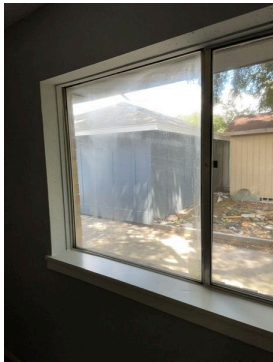
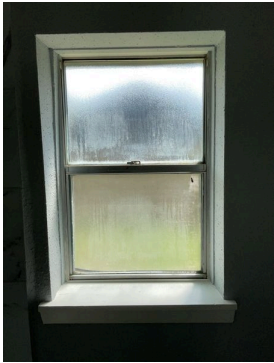
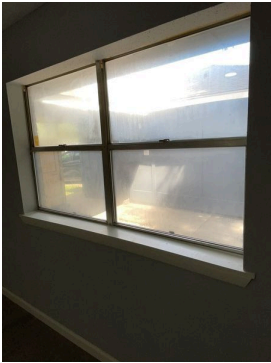
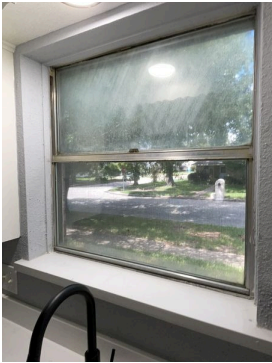
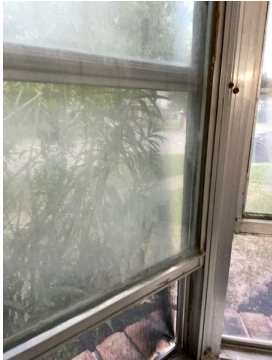
Multiple double-pane aluminum windows appeared to have lost the gas seal. The loss of the seal can lead to reduced energy efficiency and moisture damage. Recommend you have a qualified window expert evaluate the affected window(s) and provide an estimate for repairs/replacement, as necessary.

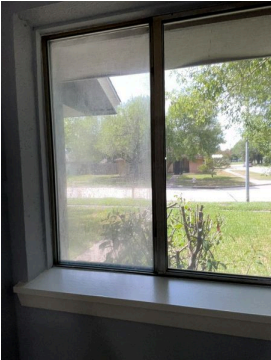
There was an inoperable window observed in bedroom number 2.

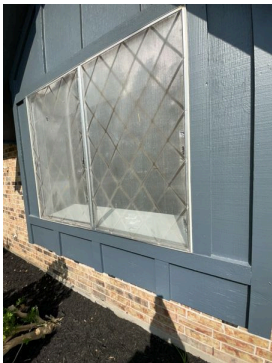
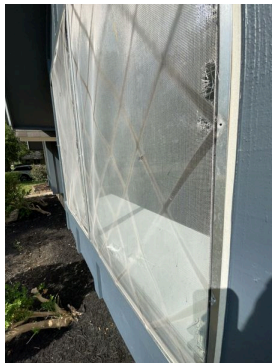
One or more windows had minor damage, including a damaged window screen.

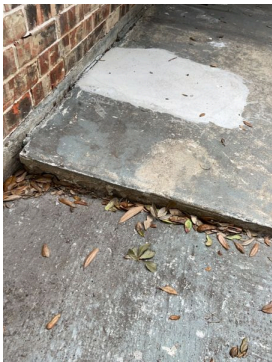
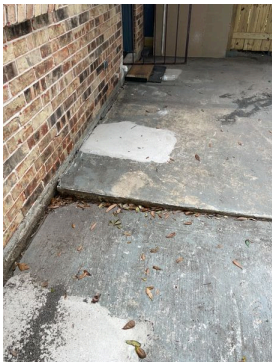
Porch or balcony exterior flooring (concrete patio) shows evidence of lifting that creates a trip hazard and signs of foundation cracking. Recommend a concrete contractor evaluate and repair.

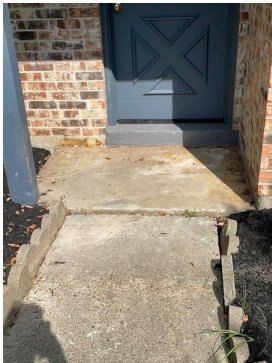
Porch or balcony exterior flooring at the front door entry shows signs of foundation lifting and is a trip hazard. Recommend a concrete contractor evaluate and repair.

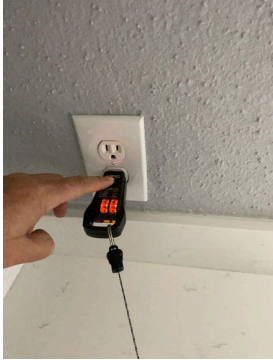
GFCI protection was not present in the kitchen in one or more required location(s) within 6 feet of running water. These may not have been required at the time the home was constructed. Recommend installing GFCI outlets or breakers to reduce the risk of shock.

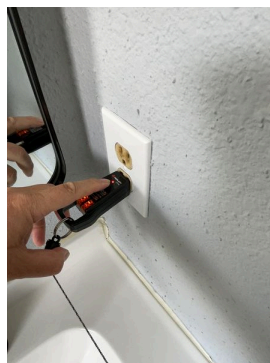
GFCI protection was not present in the master bathroom, a required location within 6 feet of running water. These may not have been required at the time the home was constructed. Recommend installing GFCI outlets or breakers to reduce the risk of shock.

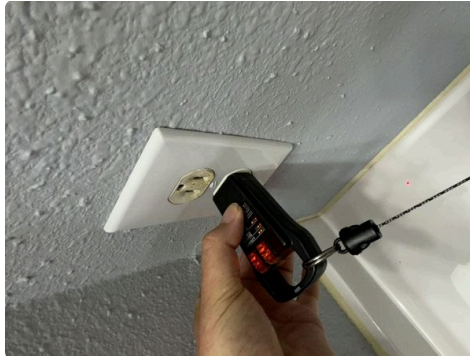
GFCI protection was not present in the hallway guest bathroom within 6 feet of running water. These may not have been required at the time the home was constructed. Recommend installing GFCI outlets or breakers to reduce the risk of shock.

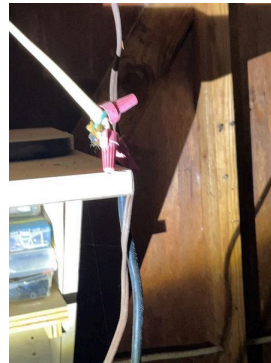
There was an electrical splice/junction in the garage that was not contained in a junction box. All wire connections & charged wires with exposed ends and splices should be covered in junction boxes for safety.

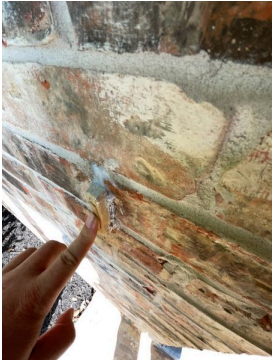
Door bell not functioning when pressed.

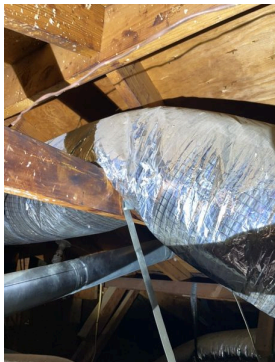
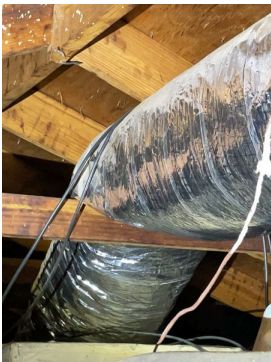
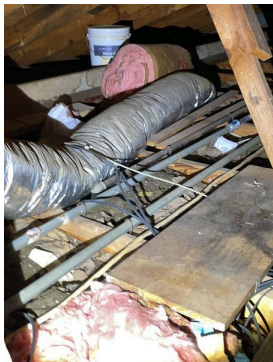
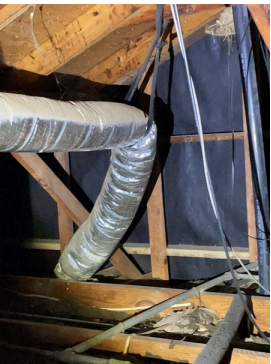
Some ducts not properly hung and can lead to various problems, including reduced airflow, moisture buildup, uneven temperatures, and increased energy bills. Properly hanging ductwork is crucial for maintaining airflow, distributing conditioned air effectively, and ensuring the system's overall efficiency.

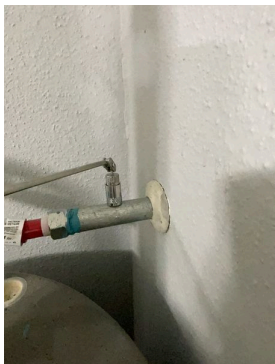
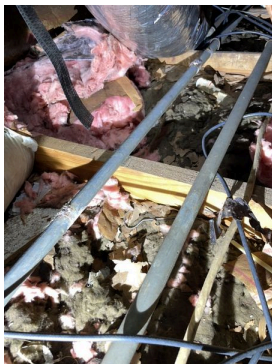
Galvanized pipes were observed in the plumbing. Galvanized pipes are steel or iron pipes coated with zinc to prevent rusting and corrosion. Almost all residential galvanized steel pipes have reached or exceeded their expected lifespan of 40 to 60 years, as their use in home construction was largely phased out by the 1960s.

- Chronically low water pressure, especially in showers or fixtures farthest from the main water line.
- Discolored, brown, or yellow water when you first turn on the tap.
- Frequent leaks at threaded joints or pinhole leaks along the pipe runs.

While galvanized pipes were once a common choice, modern materials like PEX and copper are preferred due to their durability and resistance to corrosion.

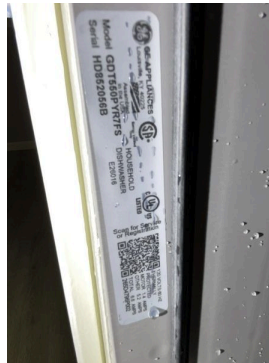
According to Label: Noted GE dishwasher, Est: 2026, model GDT550PYR7FS, S/N HD852056B.

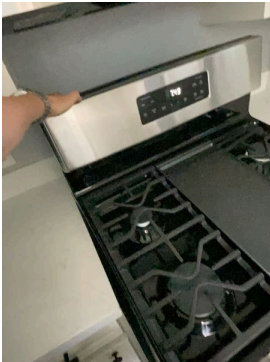
There was no anti-tip device observed on the stove. This is a safety device designed to prevent the unit from tipping and injuring a child. Recommend installation.

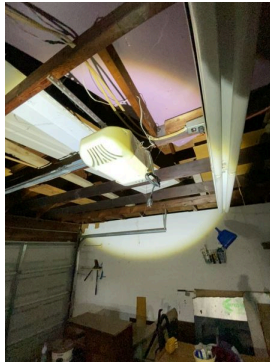
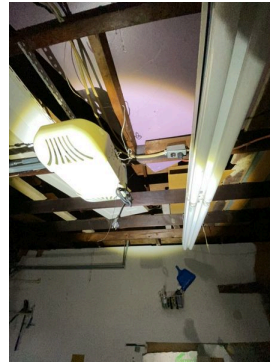
Garage door motor was not operational or not fully installed. The garage door opener is disconnected and was unable to be tested. I disengaged the door from the motor and garaged the door roll smoothly without issue.
